OFFICE OF NAVAL RESEARCH
CONTRACT NO. N00014-75-C-0944, NR 031-780

INTERIM
TECHNICAL REPORT
for the period
July 1, 1976 to June 30, 1977

"PREVENTION OF HYDROGEN-INDUCED
CRACKING IN HY-130 WELDMENTS"

Rensselaer Polytechnic Institute
Troy, N. Y. 12181

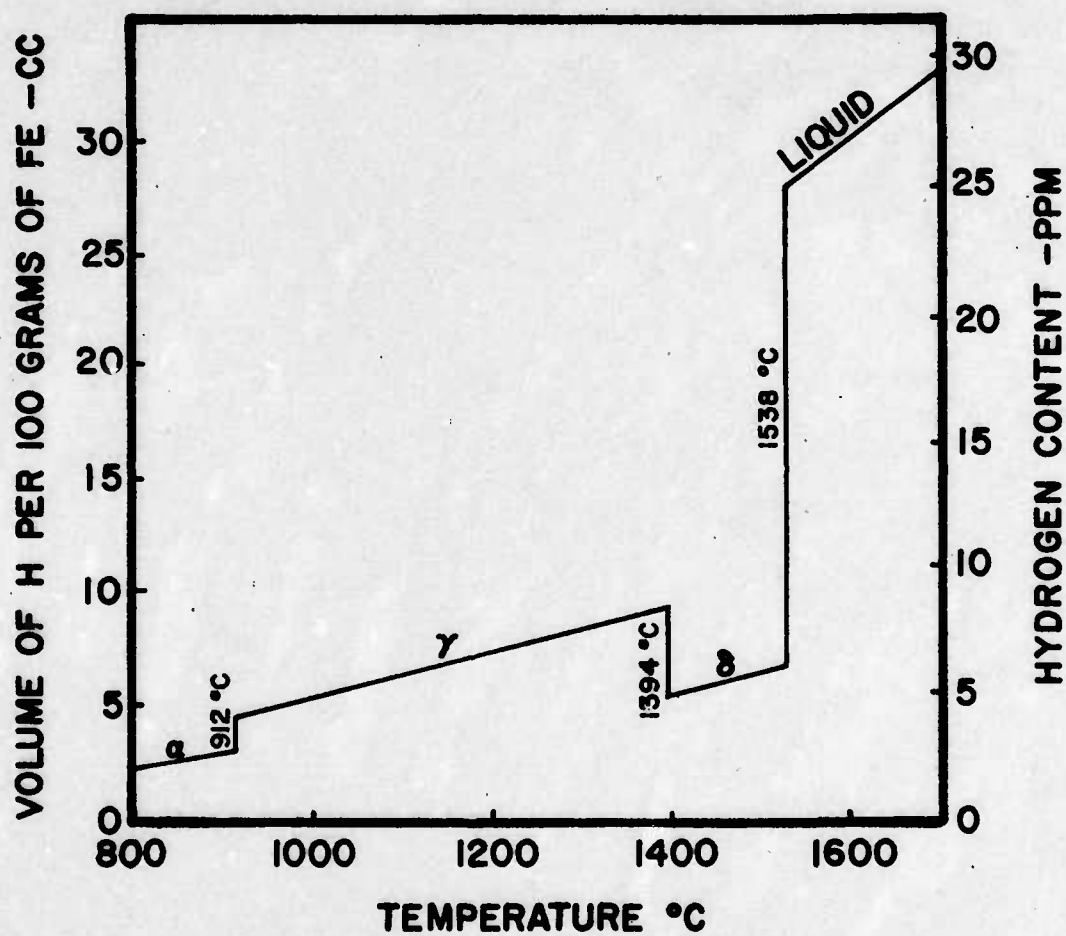
Figure 1

THE SOLUBILITY OF HYDROGEN IN IRON
AT ONE ATMOSPHERE PRESSURE

face-centered cubic austenite at 1394°C . The solubility in austenite decreases continuously to about 4.1 ppm at 9.2°C and then drops to 2.7 ppm when the austenite transforms to ferrite at 912°C . The solubility in ferrite then decreases to less than 0.5 ppm at ambient temperature.

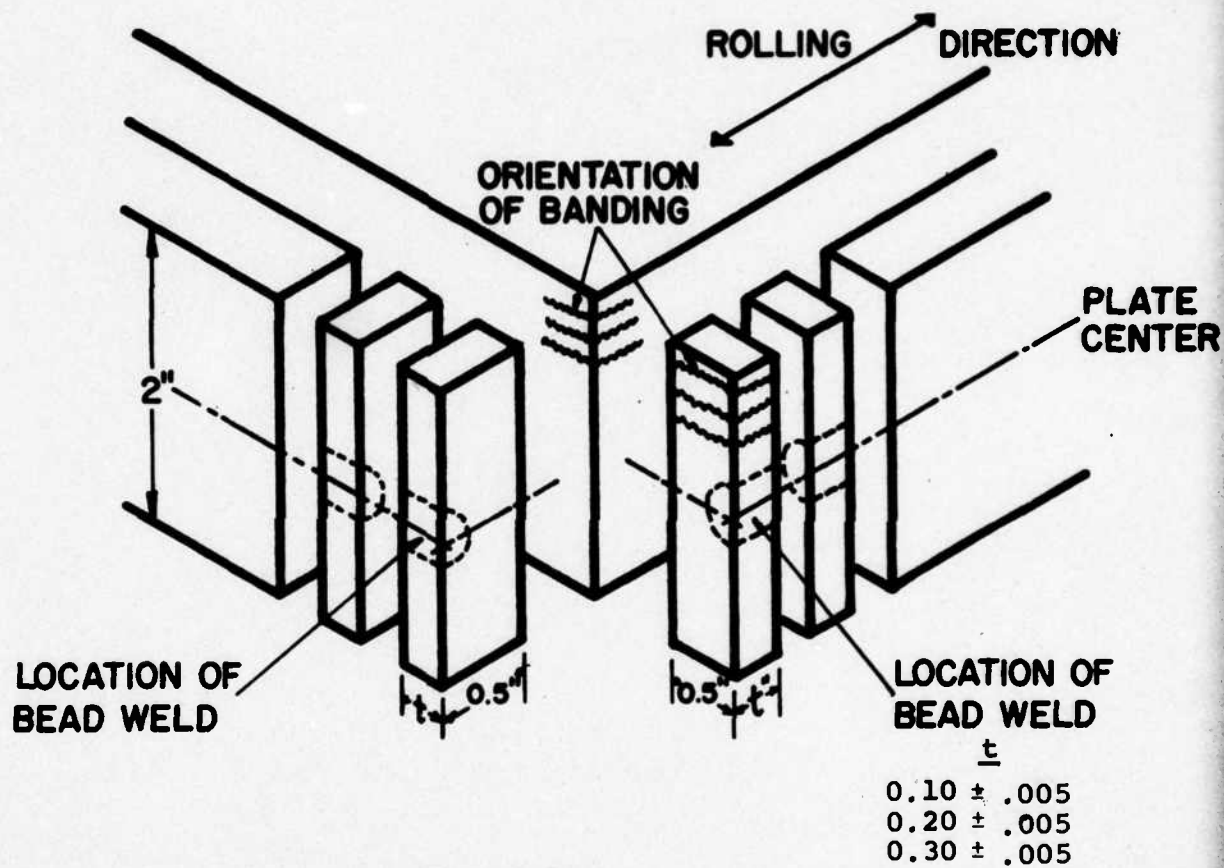
Figure 3

Orientation of the ASC Test Specimens Machined from the As-received HY-130 Steel Plates.

To investigate the effect of the differing inclusion morphologies on hydrogen cracking, test specimens were cut from each 2-in. thick plate, as illustrated in Fig. 3. With this orientation, the location of each deposited weld bead corresponded to the mid-thickness of the as-received steel plates.

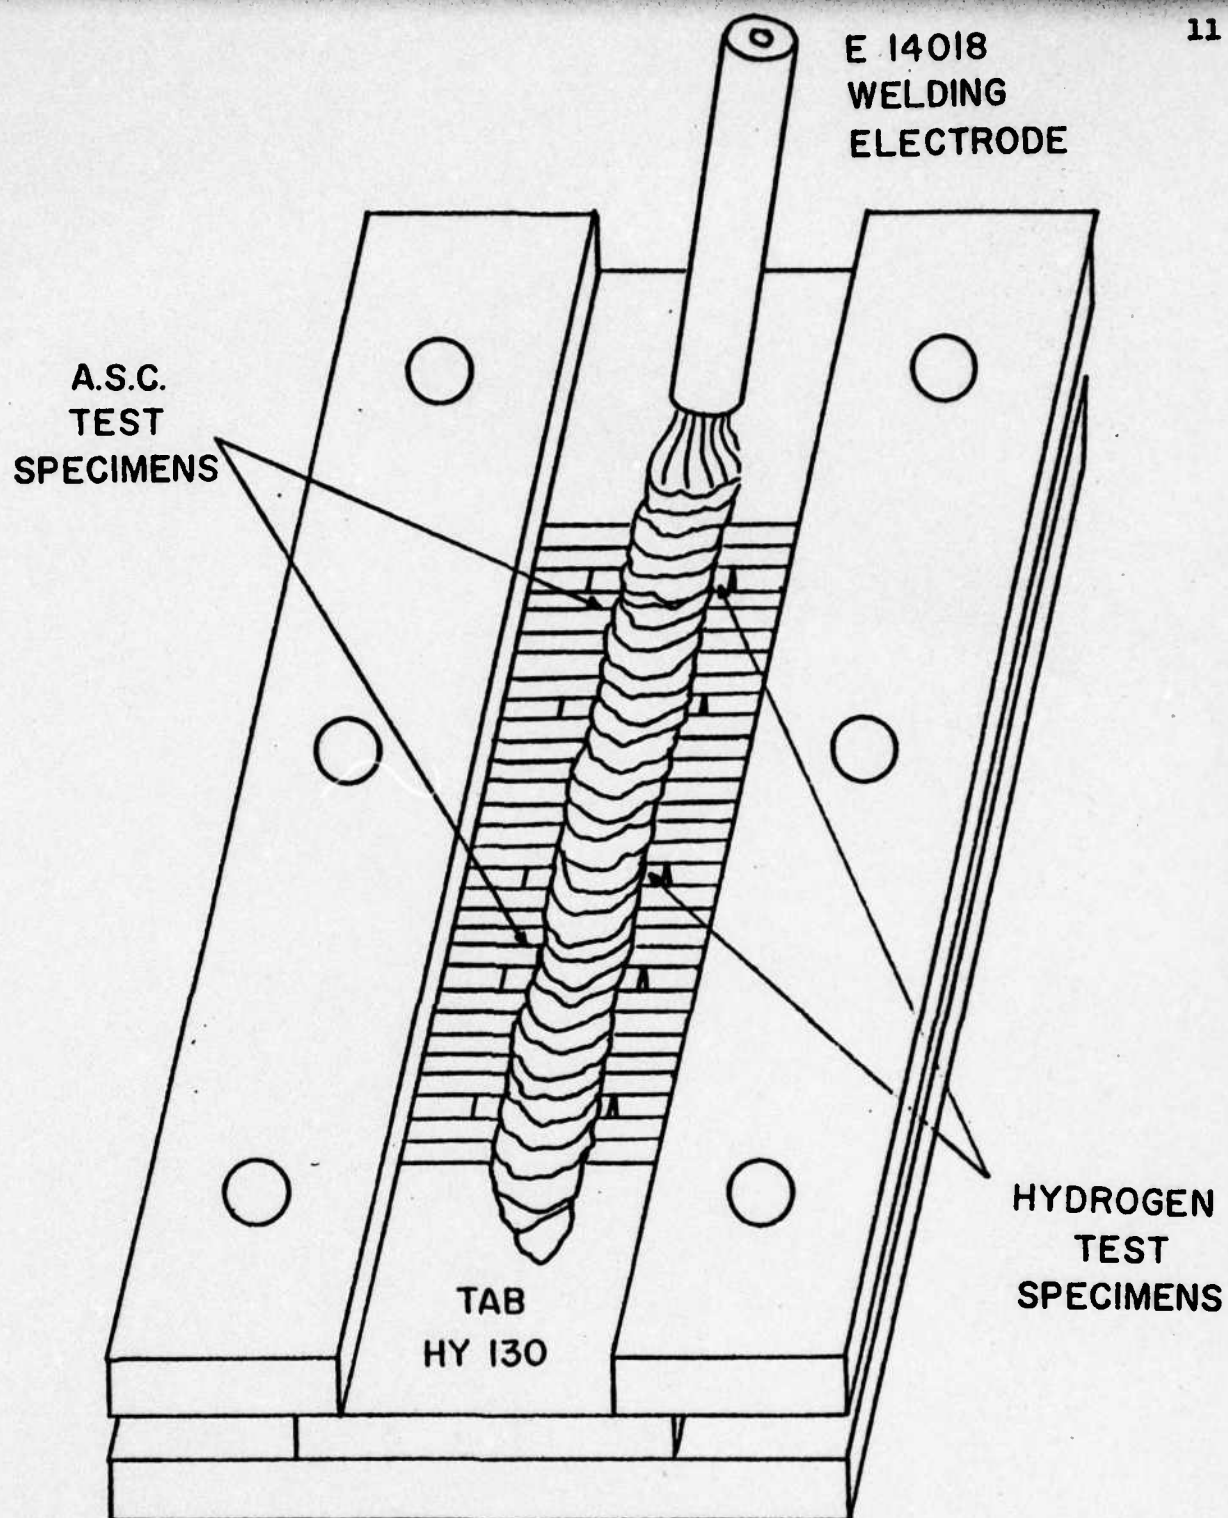
Figure 4

Schematic Illustration Showing the Welding of ASC
Test Specimens

The BWRA/IIW technique¹⁸ was employed for determining the amount of diffusible hydrogen in the weld deposits. Five hydrogen-analysis specimens were taken from each weld bead. (Fig. 4). As

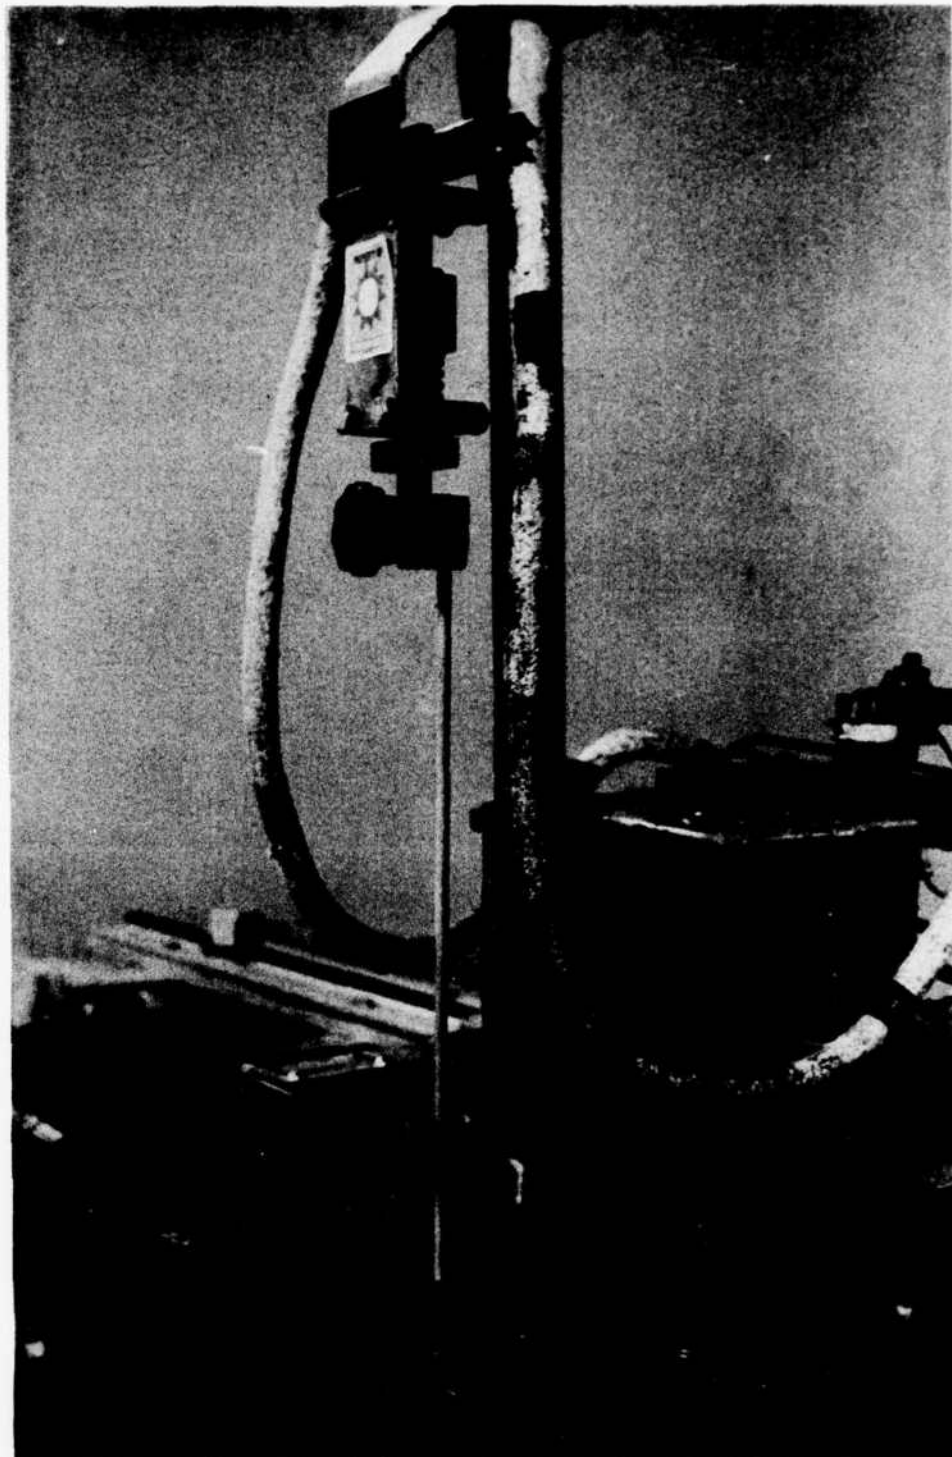
Figure 5

Automatic Stickfeeder Unit for Shielded Metal Arc Welding.
Welding Fixture is Directly under the Electrode.

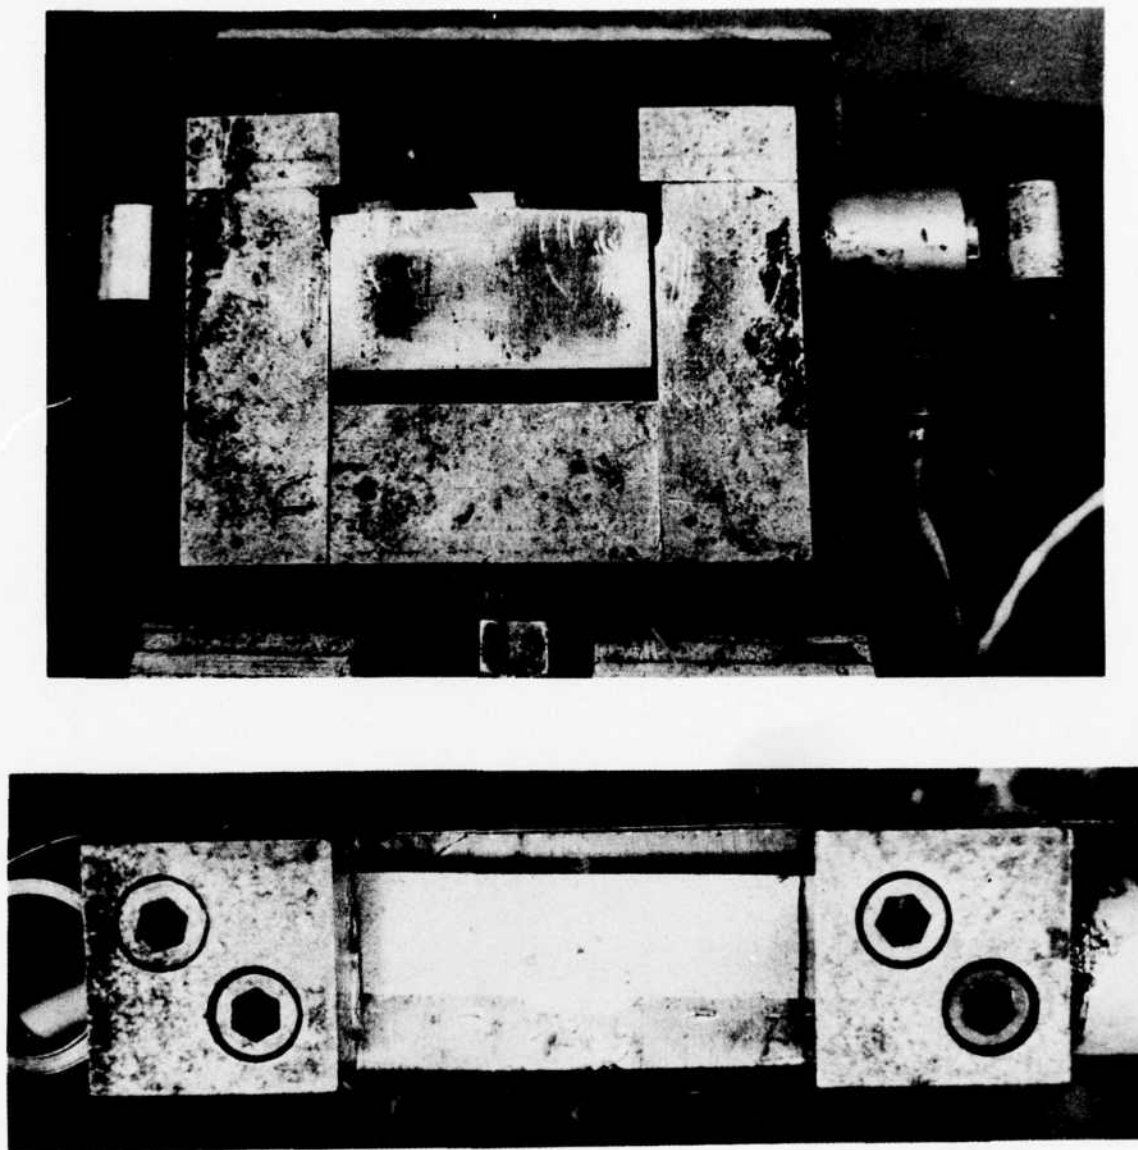
Figure 6

The Augmented Strain Cracking Test Device with Acoustic-Emission Transducer Attached
Top: Overall Side View of the Testing Device.
Bottom: Close-up Top View Showing the Positioning of ASC Test Specimen.

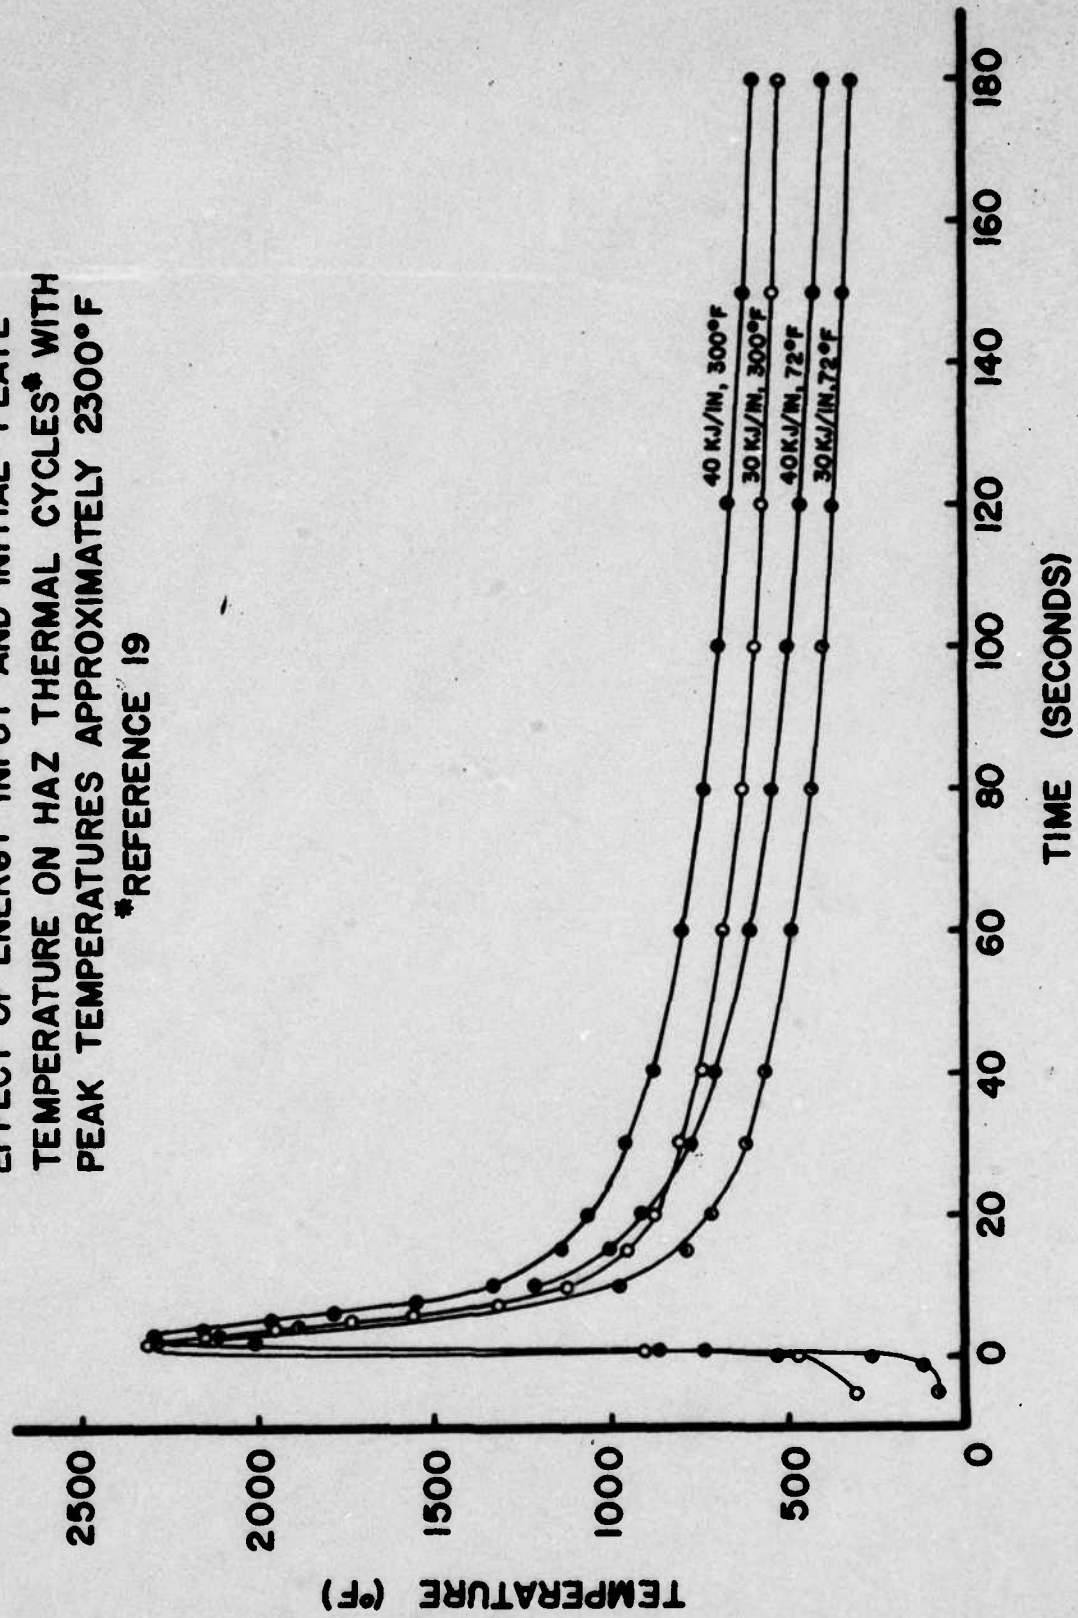
Figure 10

EFFECT OF ENERGY INPUT AND INITIAL PLATE
TEMPERATURE ON HAZ THERMAL CYCLES* WITH
PEAK TEMPERATURES APPROXIMATELY 2300°F

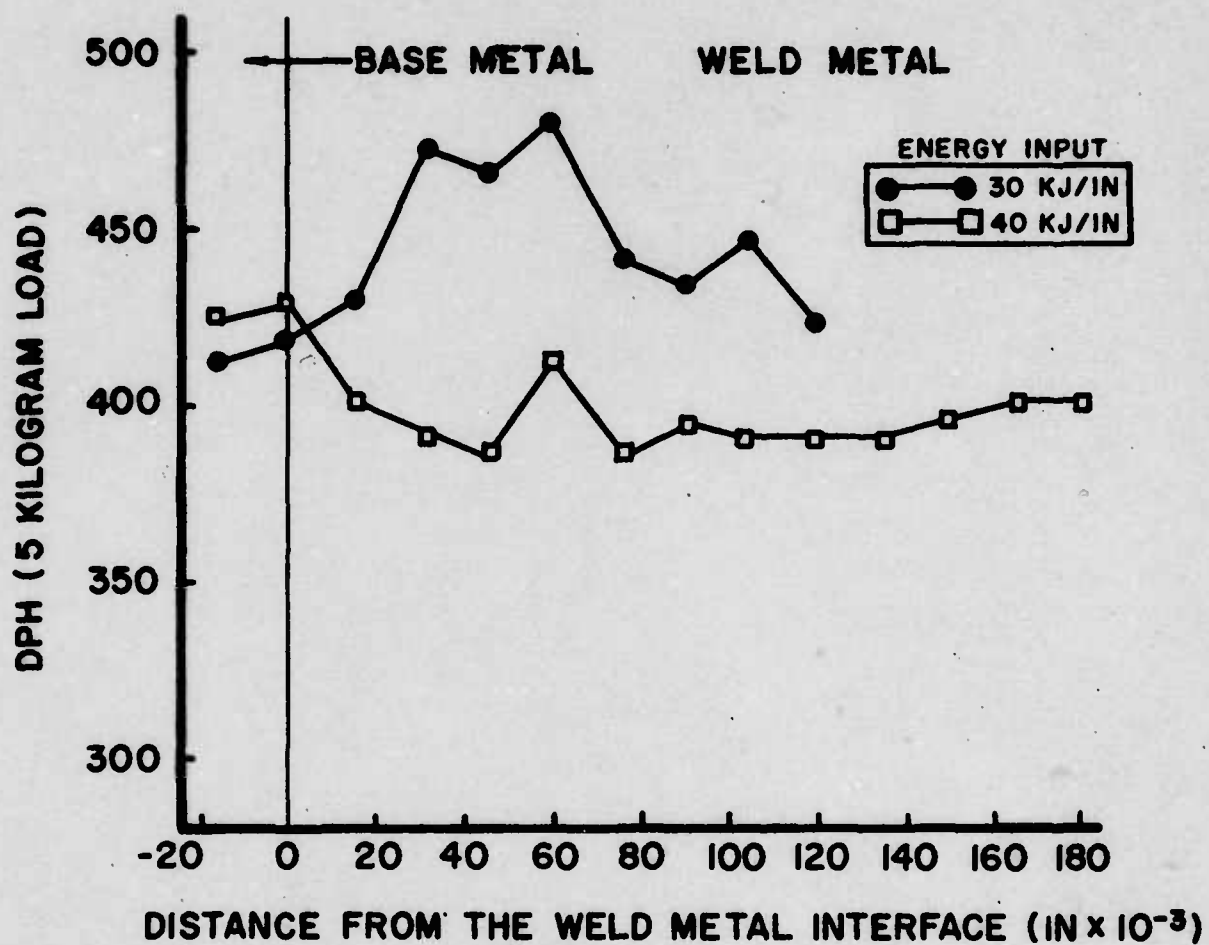
Figure 11

Measured Hardness across Weld Beads from the Two Energy Inputs Used, 300°F Preheat.

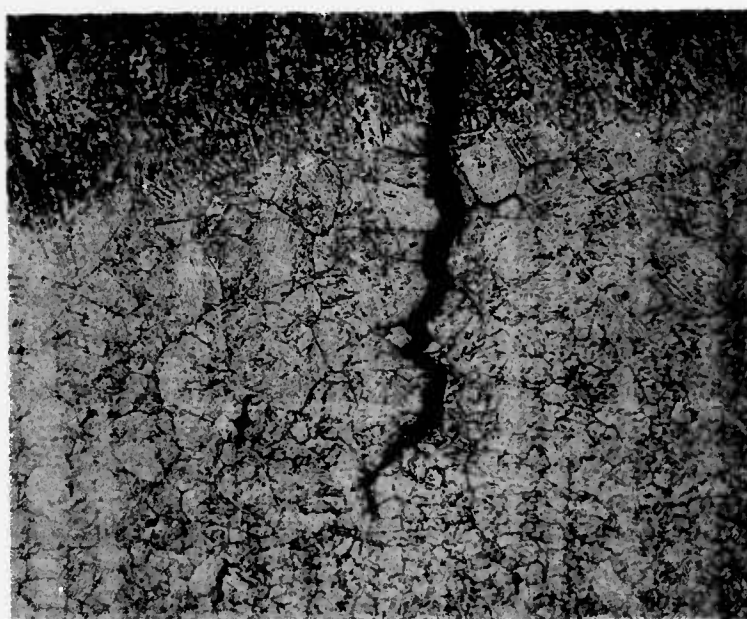
Figure 13

Macrocrack which Initiated in the Weld Metal and
Propagated into the Heat-Affected Zone.
Etching Procedure B, 75X.

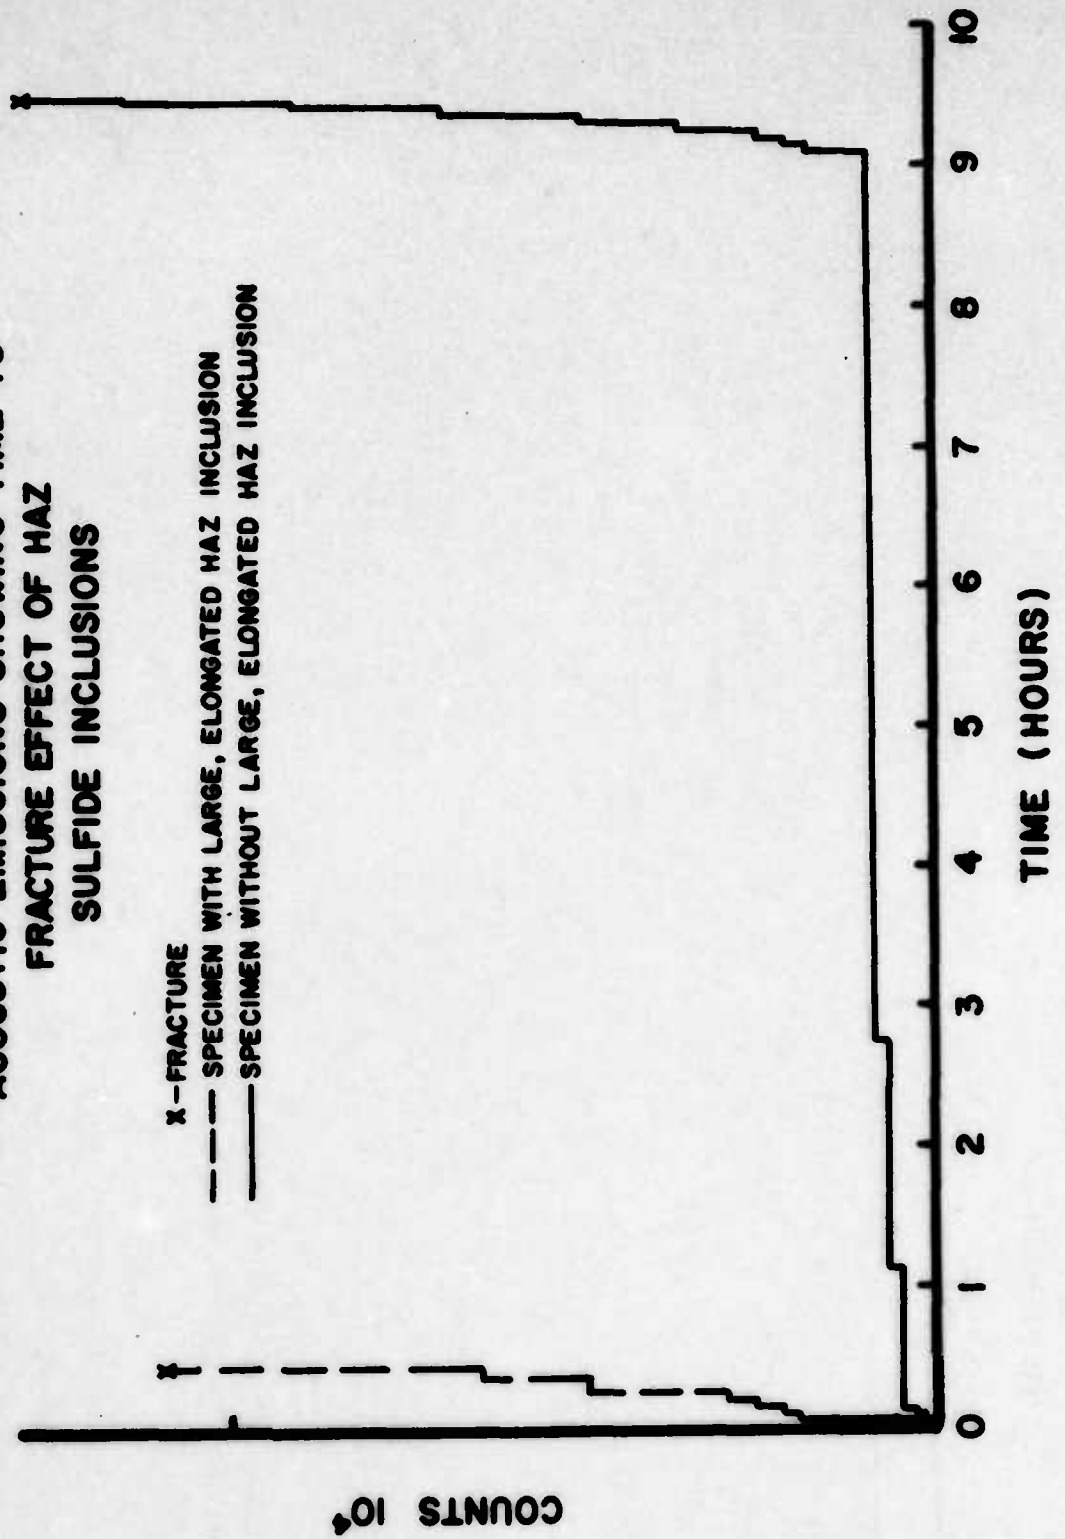
ACOUSTIC EMISSIONS SHOWING TIME TO
FRACTURE EFFECT OF HAZ
SULFIDE INCLUSIONS

Acoustic-emission results confirm the effect of an elongated sulfide inclusion on the time for crack initiation and fracture in an ASC specimen tested with 0.5% strain. Figure 16 is a plot of acoustic-emission counts vs time taken during ASC testing of 2 specimens of Heat A subjected

to the same weld-pass, preheat, and postheat treatments. Crack initiation in the specimen with a large elongated inclusion in the HAZ occurred almost immediately after application of load, and propagation to failure required less than 30 mins. Subsequent metallographic examination revealed that no such large inclusions were present in the other specimen of Heat A. In this specimen, nucleation was retarded significantly and propagation to failure required nearly 10 hrs. Figure 17, a, b, and c, show several examples of microcracking extending from non-metallic inclusions in both heats of HY-130. Note that while cracking associated with these inclusions was predominately intergranular, in a few instances the cracks were able to propagate across grains. Also, note the plastic flow of the metal matrix surrounding the elliptical inclusions shown in Fig. 17c.

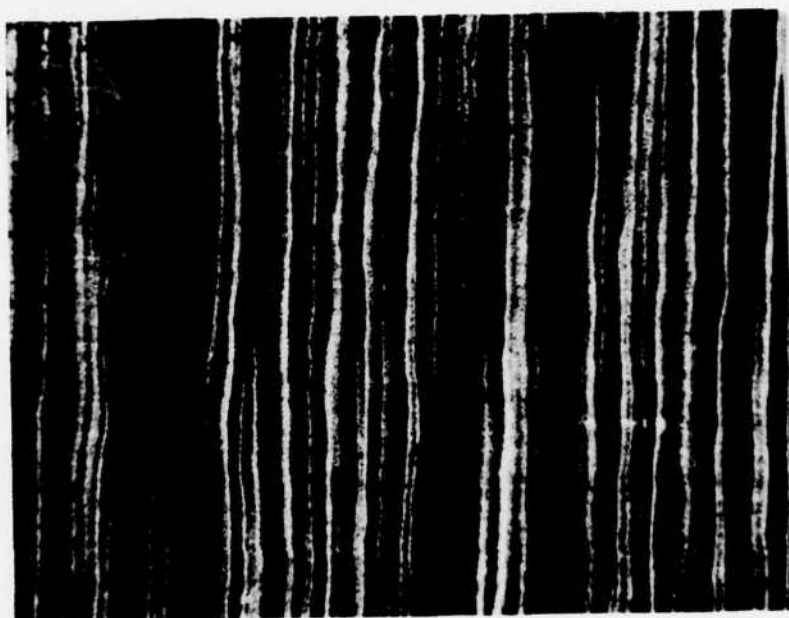
Typical Banding in Both Heats of HY-130. Etch
Procedure A, 100X.

c. Influence of banding upon heat-affected zone cracking. Metallographic examination revealed that the two heats of HY-130 were heavily banded. Figure 19 shows typical banding as revealed by a solute-sensitive etchant. The light-etching bands are higher in alloy content than the dark-etching bands, and thus correspond to the regions last to freeze between the dendritic arms in the original ingot. During subsequent hot-rolling, these segregated regions are converted to bands which are not eliminated by normalizing treatments.

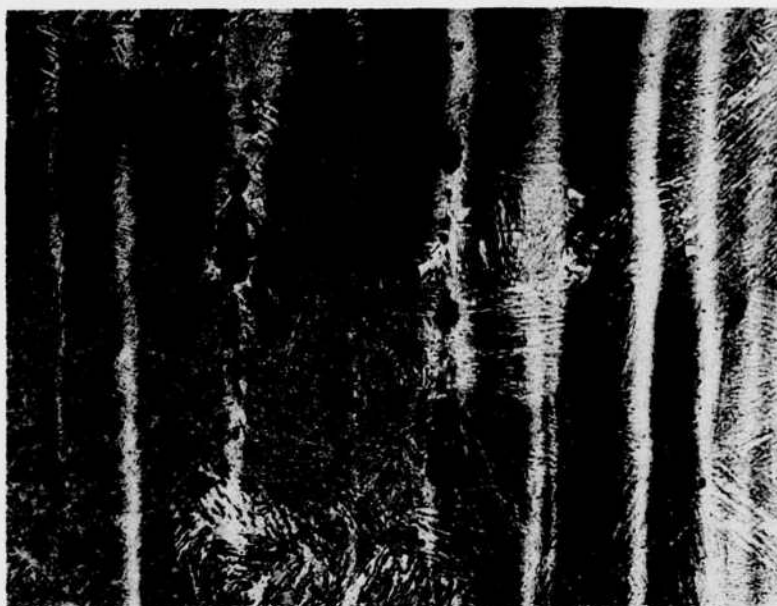
Figure 20

Elongated Non-metallic Inclusions Found in Alloy-Rich Bands of the Base Metal. Etch Procedure A, 500X.

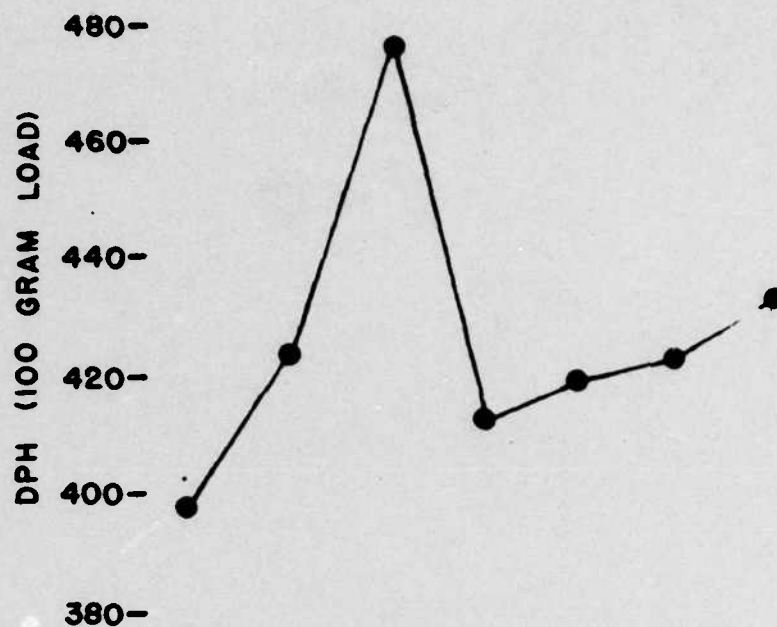
Figure 22

Hardness Transverse Across Bands in an HY-130 Heat-Affected Zone, DPH, 100 gm. load. Picric Acid Etch, 200X. The picric acid etch darkens solute rich areas whereas etch procedure A darkens solute lean areas.
